Home Report

Scottish Single Survey

Property address	14 The Park Whithorn Newton Stewart DG8 8PL
-------------------------	--

Prepared by	Shepherd Chartered Surveyors
--------------------	------------------------------

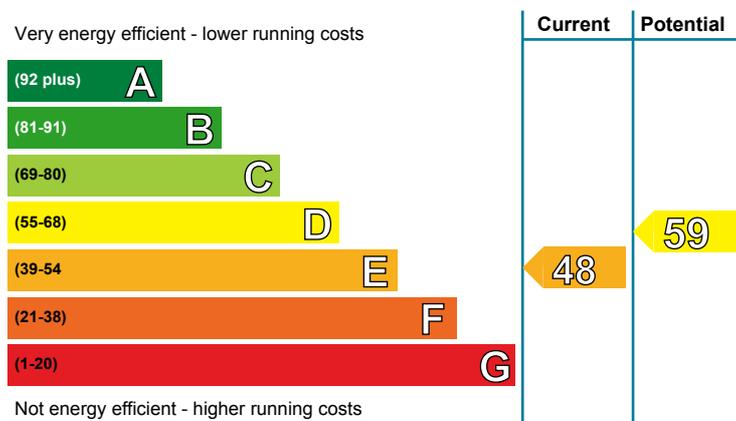
Energy Efficiency Rating

This graph shows the current efficiency of your home, taking into account both energy efficiency and fuel costs. The higher this rating, the lower your fuel bills are likely to be.

Your current rating is **band E (48)**. The average rating for EPCs in Scotland is **band D (61)**.

The potential rating shows the effect of undertaking all of the improvement measures listed within your recommendations report.

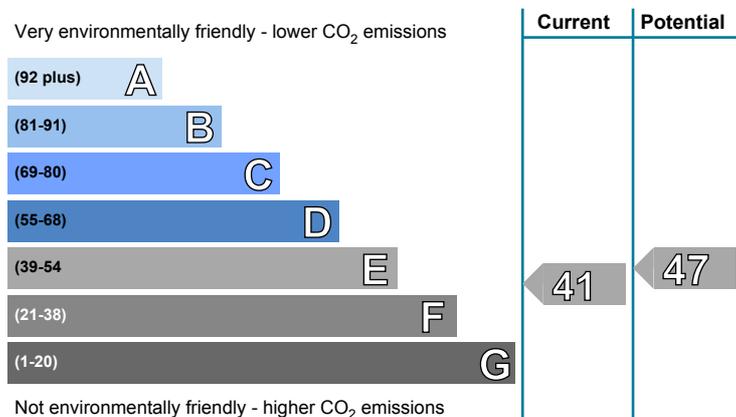
Environmental Impact (CO₂) Rating

This graph shows the effect of your home on the environment in terms of carbon dioxide (CO₂) emissions. The higher the rating, the less impact it has on the environment.
