# Home Report

# Single Survey

| Property address | 46 Laigh Isle<br>Isle Of Whithorn<br>Newton Stewart<br>DG8 8LS |
| Prepared by | Shepherd Chartered Surveyors |

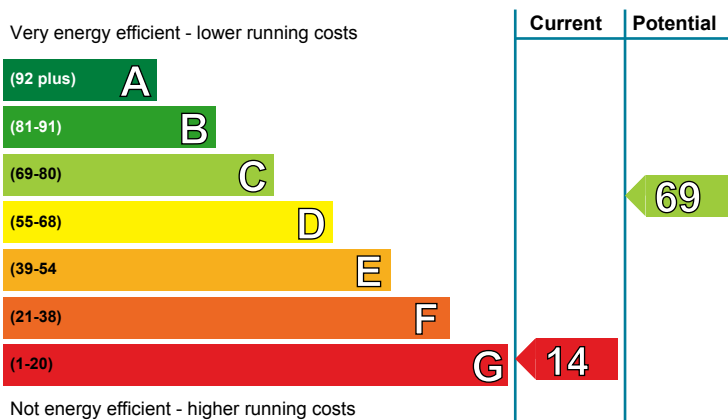
## Energy Efficiency Rating

This graph shows the current efficiency of your home, taking into account both energy efficiency and fuel costs. The higher this rating, the lower your fuel bills are likely to be.

The potential rating shows the effect of undertaking all of the improvement measures listed within your recommendations report.
