# Home Report

# Single Survey

<b>Property address</b>	Landberrick Cottage Whauphill Newton Stewart DG8 9PN
-------------------------	---------------------------------------------------------------

<b>Prepared by</b>	Shepherd Chartered Surveyors
--------------------	------------------------------

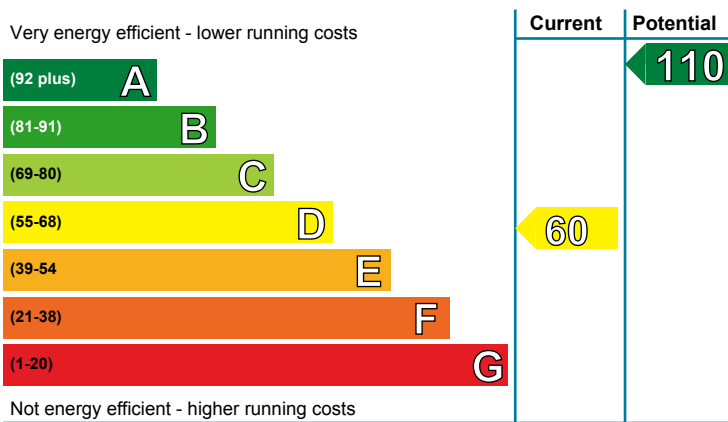
## Energy Efficiency Rating

This graph shows the current efficiency of your home, taking into account both energy efficiency and fuel costs. The higher this rating, the lower your fuel bills are likely to be.

Your current rating is **band D (60)**. The average rating for EPCs in Scotland is **band D (61)**.

The potential rating shows the effect of undertaking all of the improvement measures listed within your recommendations report.

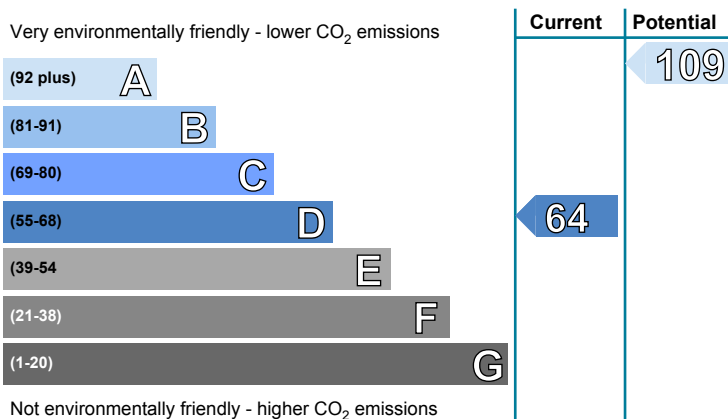
## Environmental Impact (CO<sub>2</sub>) Rating

This graph shows the effect of your home on the environment in terms of carbon dioxide (CO<sub>2</sub>) emissions. The higher the rating, the less impact it has on the environment.

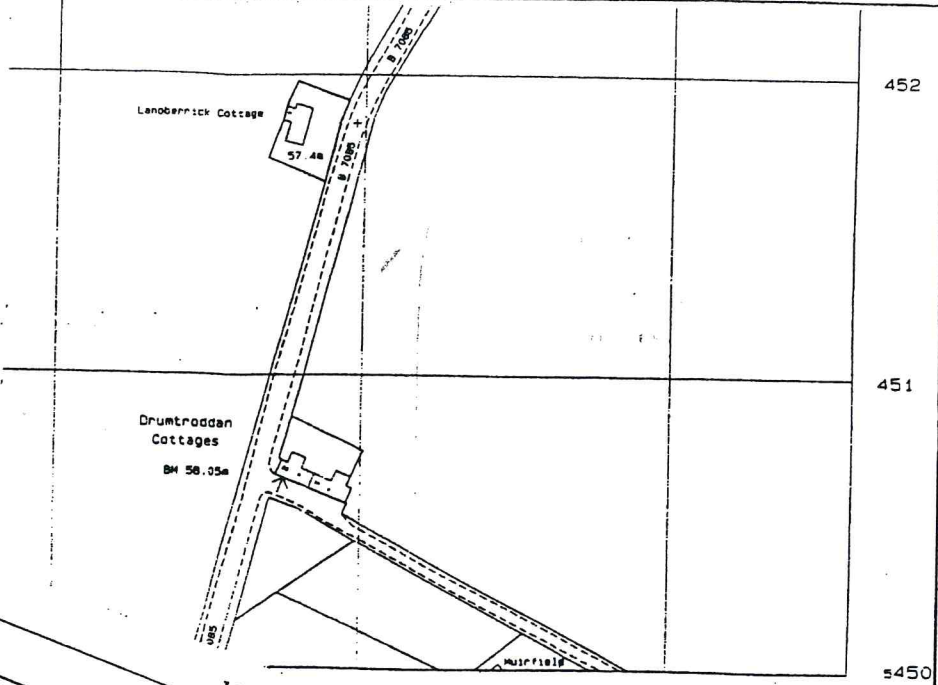
BLOCK PLAN

SCALE 1:200
