# Home Report

# Single Survey

<b>Property address</b>	Seven Oaks Main Street Glenluce Newton Stewart DG8 0PN
<b>Customer</b>	Francis Smith
<b>Customer address</b>	Seven Oaks Main Street Glenluce Newton Stewart DG8 0PN
<b>Prepared by</b>	Shepherd Chartered Surveyors
<b>Date of inspection</b>	25/04/2024

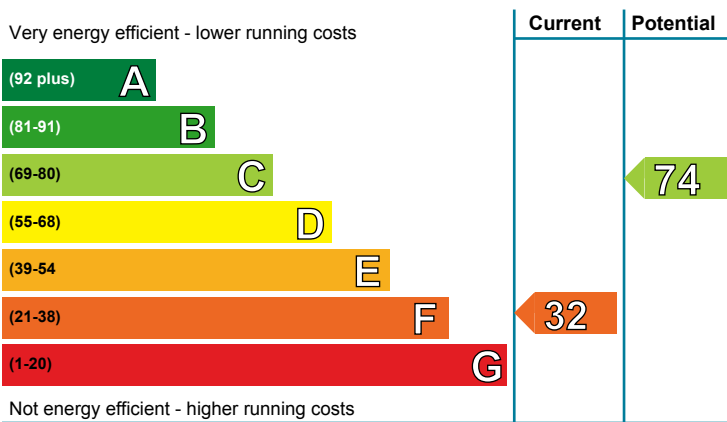
## Energy Efficiency Rating

This graph shows the current efficiency of your home, taking into account both energy efficiency and fuel costs. The higher this rating, the lower your fuel bills are likely to be.

Your current rating is **band F (32)**. The average rating for EPCs in Scotland is **band D (61)**.

The potential rating shows the effect of undertaking all of the improvement measures listed within your recommendations report.

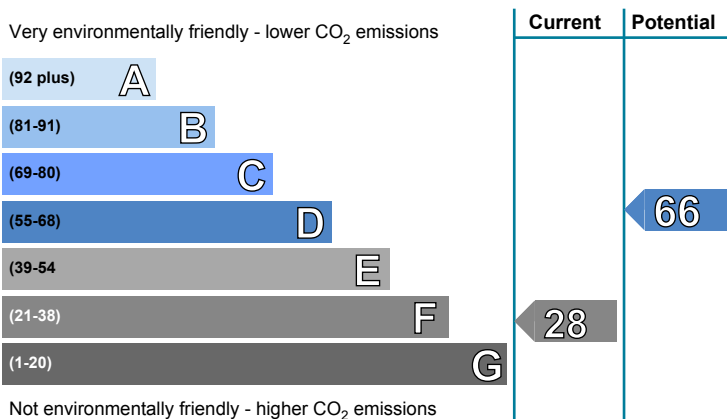
## Environmental Impact (CO<sub>2</sub>) Rating

This graph shows the effect of your home on the environment in terms of carbon dioxide (CO<sub>2</sub>) emissions. The higher the rating, the less impact it has on the environment.
