# Home Report

# Scottish Single Survey

<b>Property address</b>	5 Corvisel Road Newton Stewart DG8 6LW
<b>Customer</b>	Mr & Mrs Pitcher
<b>Customer address</b>	5 Corvisel Road Newton Stewart DG8 6LW
<b>Prepared by</b>	Shepherd Chartered Surveyors
<b>Date of inspection</b>	11/06/2024

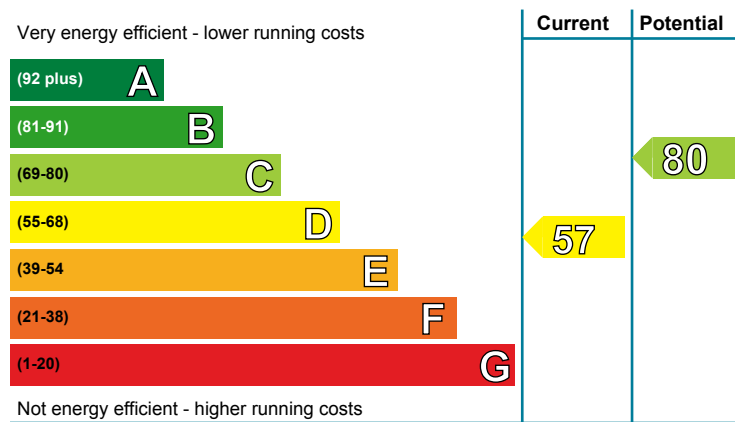
## Energy Efficiency Rating

This graph shows the current efficiency of your home, taking into account both energy efficiency and fuel costs. The higher this rating, the lower your fuel bills are likely to be.

Your current rating is **band D (57)**. The average rating for EPCs in Scotland is **band D (61)**.

The potential rating shows the effect of undertaking all of the improvement measures listed within your recommendations report.
