Scottish Single Survey

Property address	32 Queen Street Newton Stewart DG8 6JL
------------------	--

Prepared by	Shepherd Chartered Surveyors
-------------	------------------------------

Date of inspection	12/09/2024

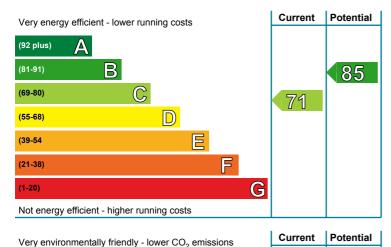
Energy Efficiency Rating

This graph shows the current efficiency of your home, taking into account both energy efficiency and fuel costs. The higher this rating, the lower your fuel bills are likely to be.
